cERL 500 kV DC-gun Achievements, troubles, technical issues

e-Linac Reliability Workshop (remote) May 9-10, 2022

> Masahiro Yamamoto KEK

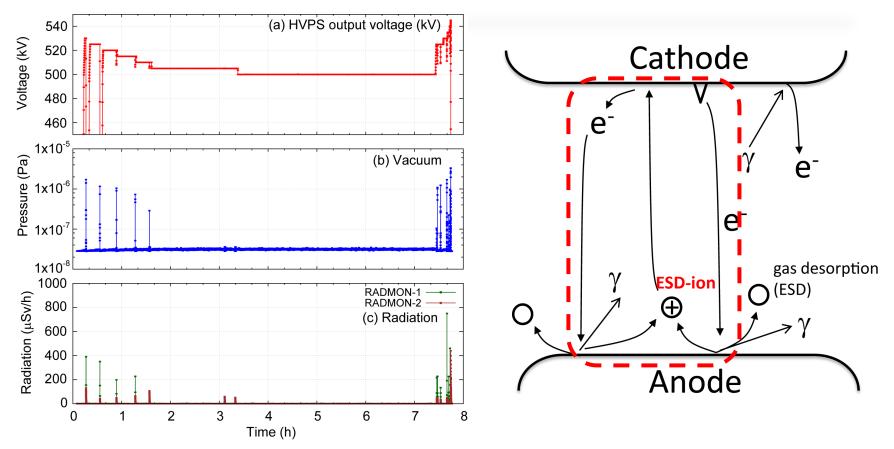
HV conditioning for stable operation (2)

- The discharge stop voltage after HV conditioning is about 502 kV.
- Discharge occurs above 505 kV. The higher the voltage, the higher the discharge frequency.
- No discharge occurs at 500 kV.

ESD-ions may form a discharge circuit.

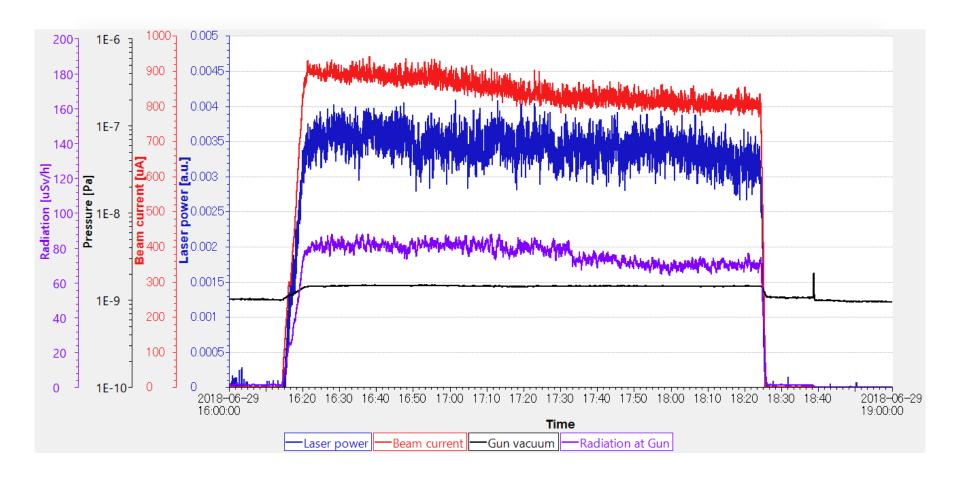
500 kV operation history (2)

- The QE decreases by about 10% in about 2 hours.
- The increase in vacuum during operation is small.
- The radiation was mainly due to beam loss in the second arc section.

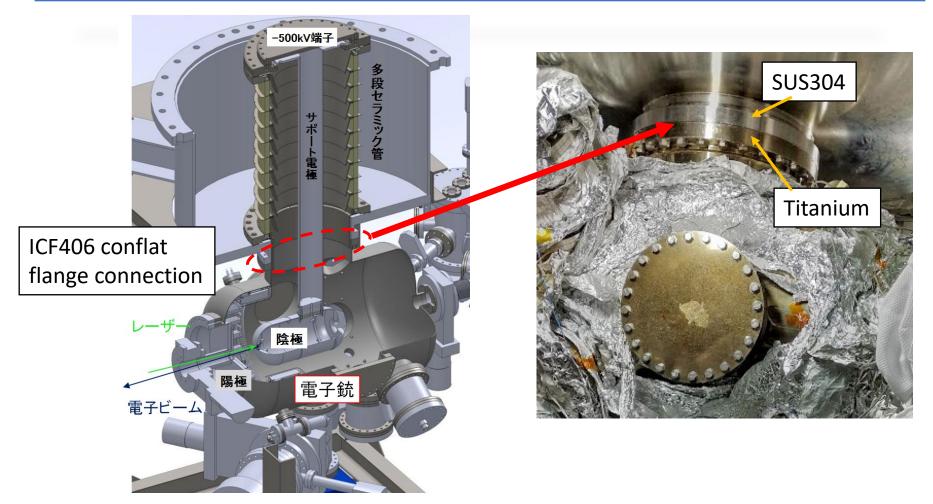
Trouble 1: Vacuum leaks

- Leakage at titanium-stainless steel large diameter flange connection.
- The cause is due to the difference in the coefficient of thermal expansion.
- Currently, VACSEAL is used to stop the leak as a first aid.
- Scheduled to be replaced with a thick gasket during this year's shutdown.

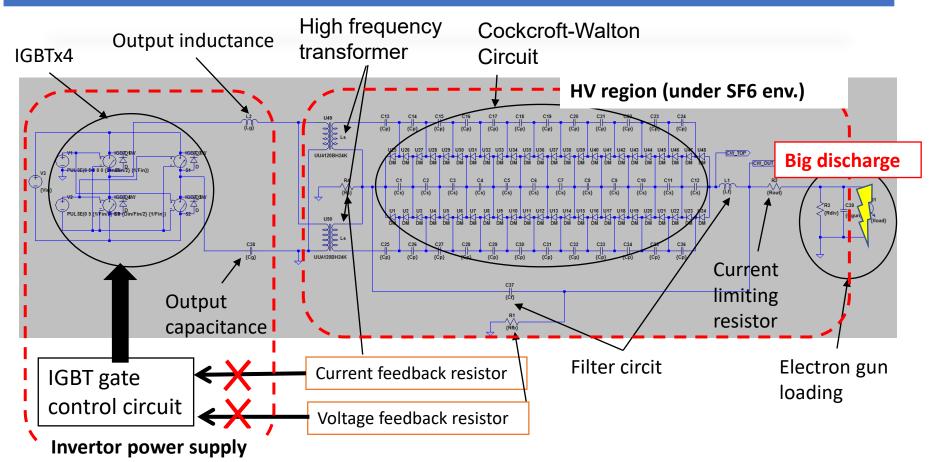
Trouble 2: Serious discharge event (1)

November 2020:

Feedback monitor line is disconnected during new inverter power supply adjustment. Turn on the power for test operation, the maximum output of \sim 600 kV can be applied instantly.

Frequent arc discharge occured for 20 second intermittently.

vacuum gauge stops abnormally and IGBT fails.

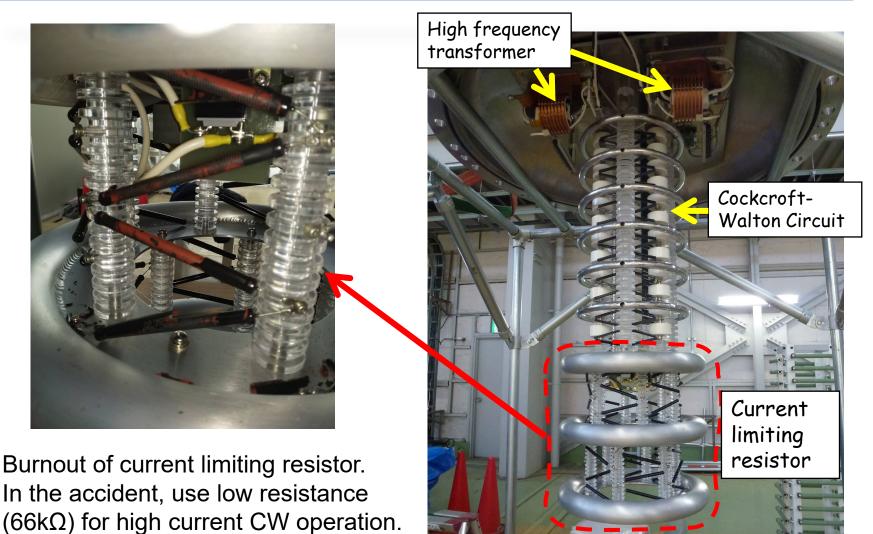
Trouble 2: Serious discharge event (2)

No particular damage other than burning of the resistor.

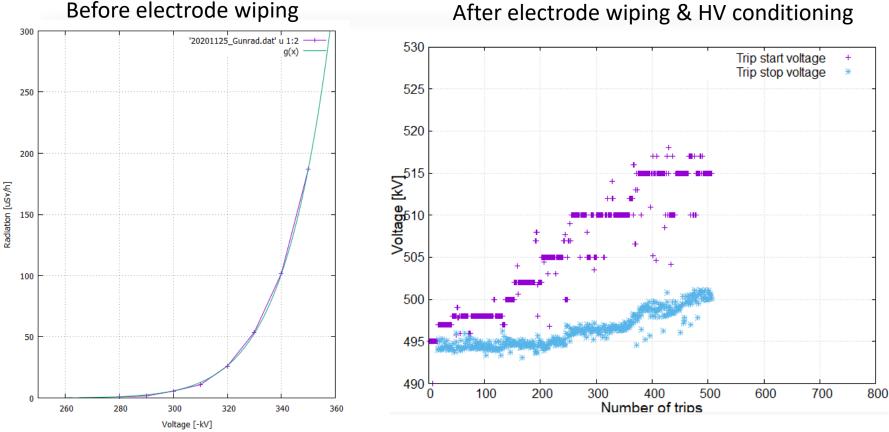
Trouble 2: Serious discharge event (3)

- The FE source disappears by wiping the electrodes. ٠
- 490kV DC-gun operation in February 2021. The FE source • reoccurs during additional conditioning.
- 390kV DC-gun operation after October 2021.

FE sources that could not be removed by conditioning could be removed by wiping with a lint-free wiper.

After electrode wiping & HV conditioning
