cERL 500 kV DC-gun Achievements, troubles, technical issues

e-Linac Reliability Workshop (remote) May 9-10, 2022

> Masahiro Yamamoto KEK

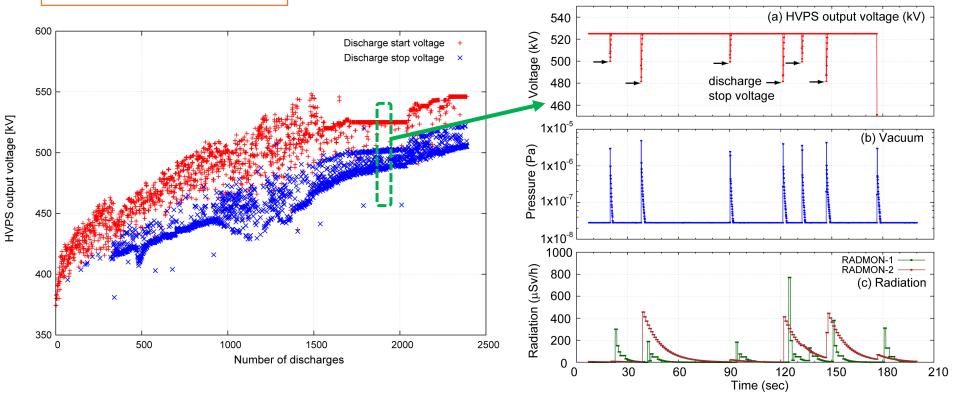
1st DC-Gun results

- The discharge voltage gradually increased while repeating many discharges.
- The discharge stop voltage has an important meaning.

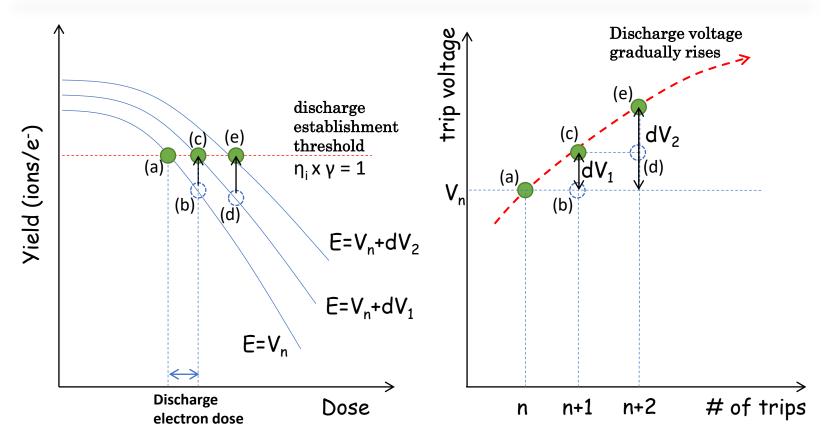
- The discharge establishment threshold is defined as the product of the yield of ESD-ion and the ratio of SE by ion impact becomes 1.
- ESD-ion yield is decrease by discharge electron impact dose.

According to this mechanism, the discharge does not occur below the discharge stop voltage. (Discharge establishment threshold \cong Discharge stop voltage)

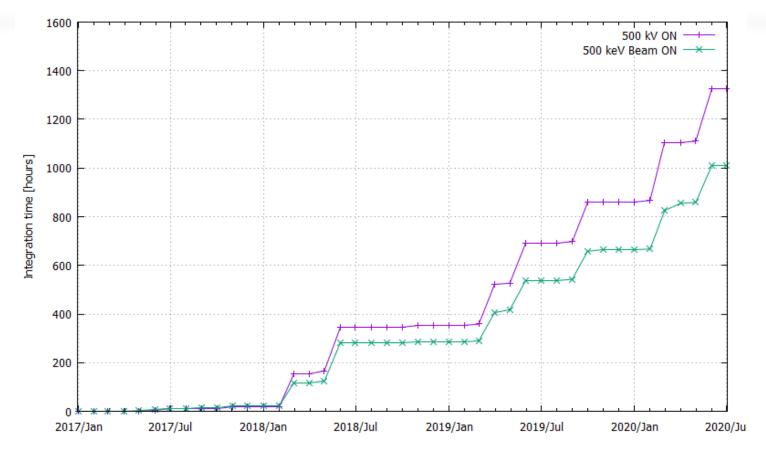
- cERL DC-gun 500 kV Operation history from May 2017 to July 2020.
- 500kV holding time 1327 hours, total beam supply 1011 hours.
- During this time, there was no discharge caused by the electron gun.

Stable operation is guaranteed below the minimum discharge stop voltage.
